Data Analysis and Interpretation
Painkalac Creek Estuary
2007-2013

Written and compiled by Stephen Harfield of Catchment Ecology Services for Corangamite Catchment Management Authority.

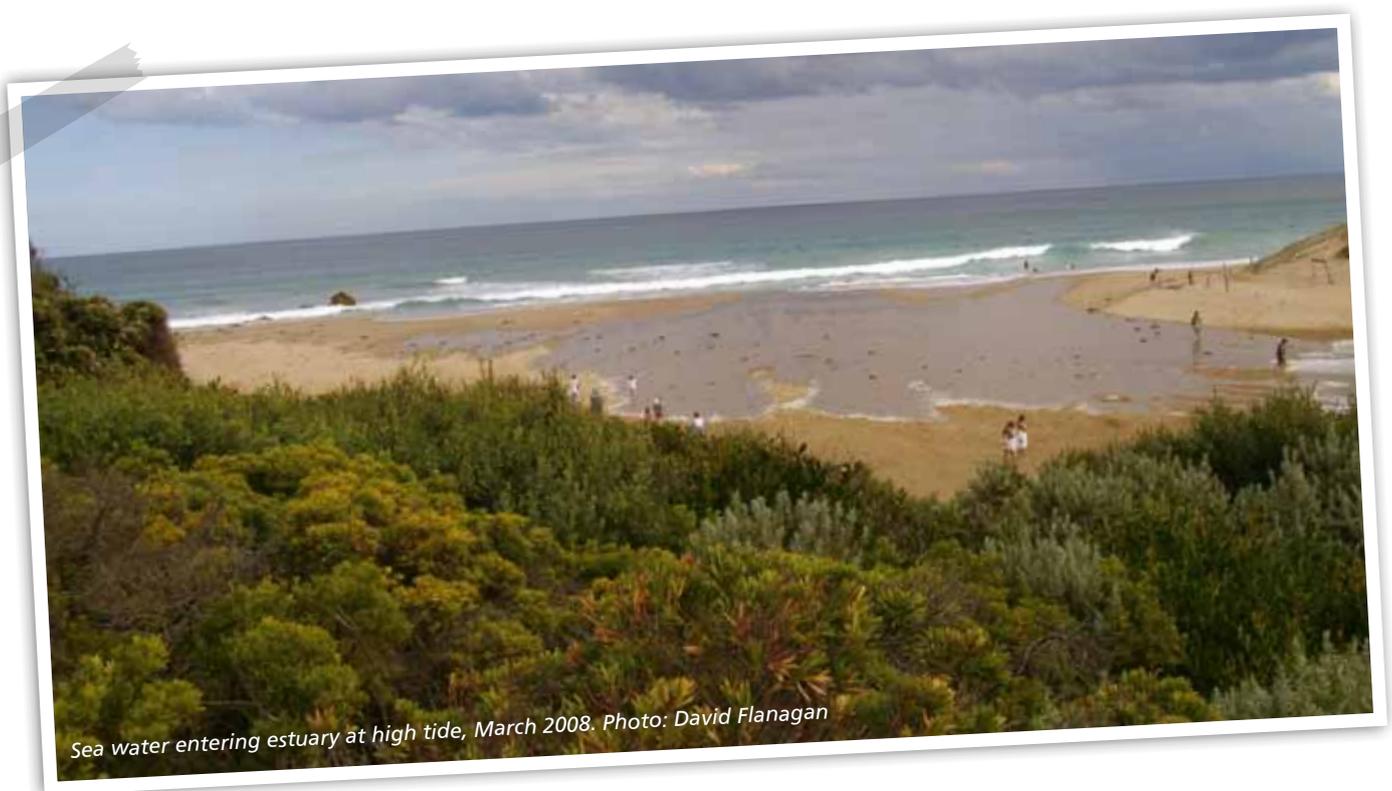
Sea water entering estuary at high tide, March 2008. Photo: David Flanagan

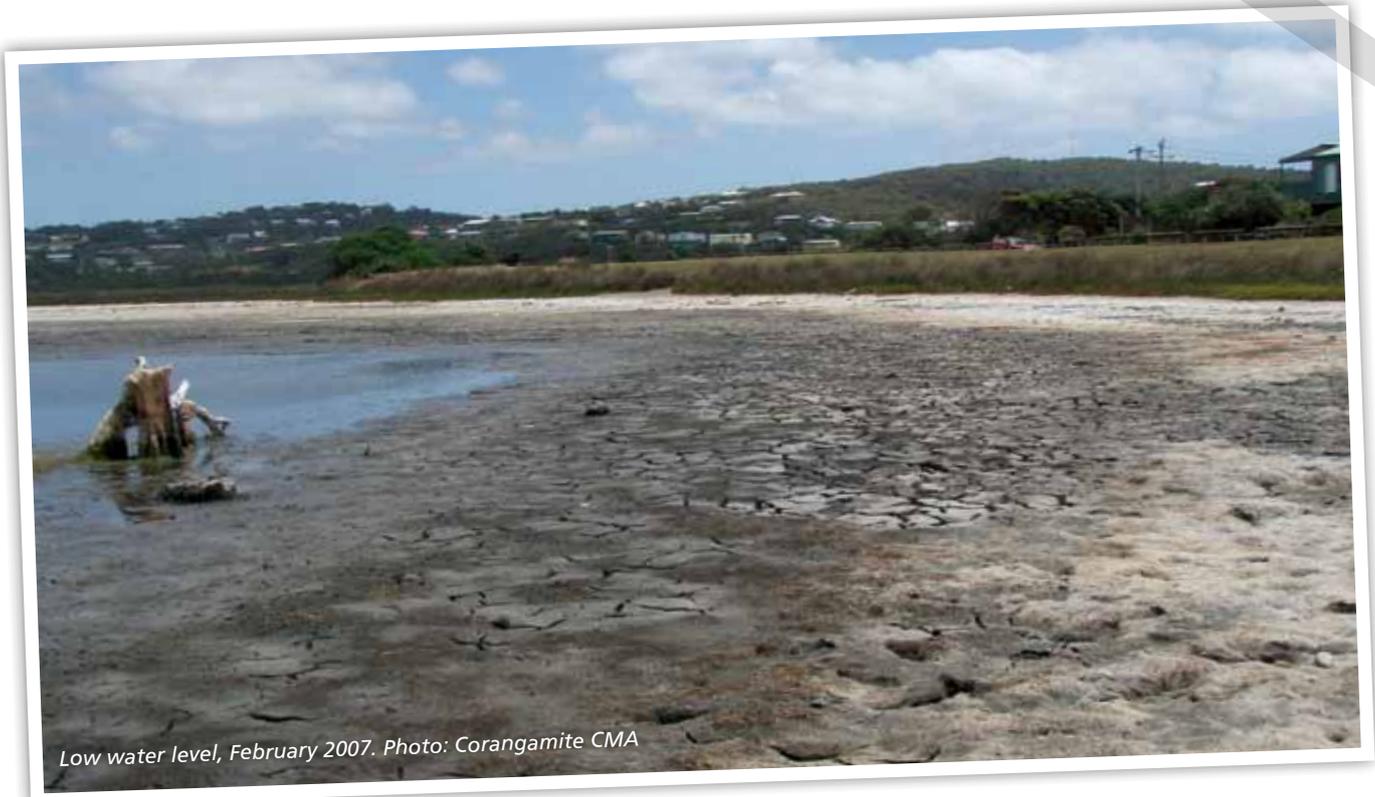
Low water level, February 2007. Photo: Corangamite CMA
