# ANGLESEA RIVER ESTUARY 2016

## An interpreted summary of data

Date range:  
01/01/2016 – 31/12/2016

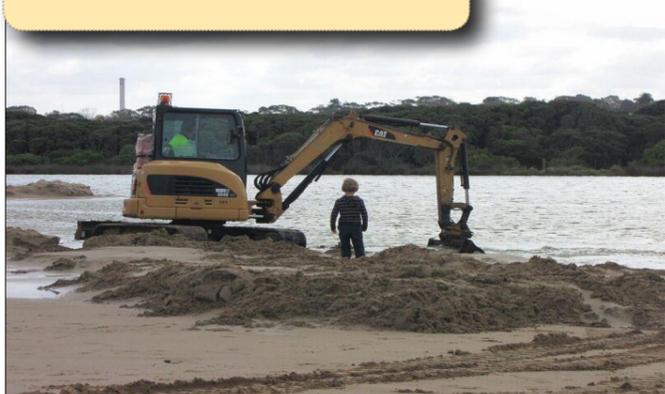
Permitted artificial estuary opening conducted on May 13.

The Anglesea River is an intermittently open estuary. In 2016 there were three permitted artificial estuary openings recorded, March 10 (1.68m AHD), May 6 (1.63m AHD) and May 13 (1.78m AHD), and potentially three natural openings on July 6 (1.71m AHD), July 29 (1.71m AHD) and September 13 (1.72 AHD). Estuary mouth closures were recorded at many other estuaries in Victoria during 2016. The lowest water temperature recorded in 2016 was 8.3°C on June 15, likely due to river inflows of winter rainfall. The highest water temperature recorded was 31.3°C on November 23 at the culvert on Coalmine Road (Site A5), an increase in temperature and salinity with depth was observed at most sites on many occasions. Over the 12 months salinity levels throughout the estuary remained brackish ranging from 1.1 – 32ppt. Dissolved oxygen levels were mostly in the healthy range (median 91% saturation) though some extremely high values were recorded from October to December. The pH ranged from 3.4 – 8.6 pH units. **EstuaryWatch records at Anglesea River estuary extend from 2007 and can be viewed at [www.estuarywatch.org.au](http://www.estuarywatch.org.au)**

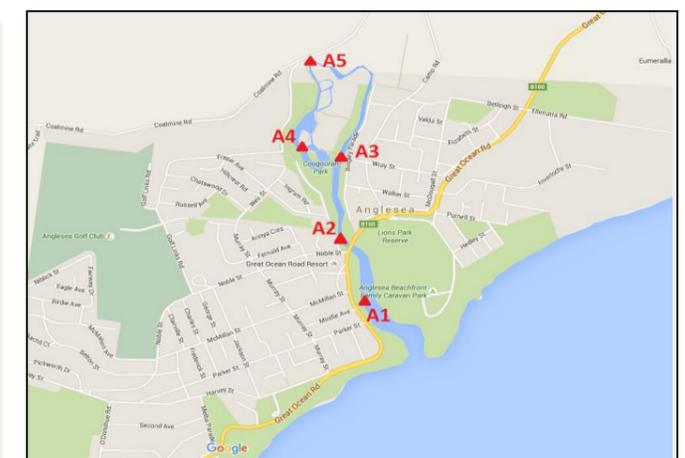
Map of the Anglesea River estuary and the location of EstuaryWatch water quality monitoring sites. Source: Google Maps

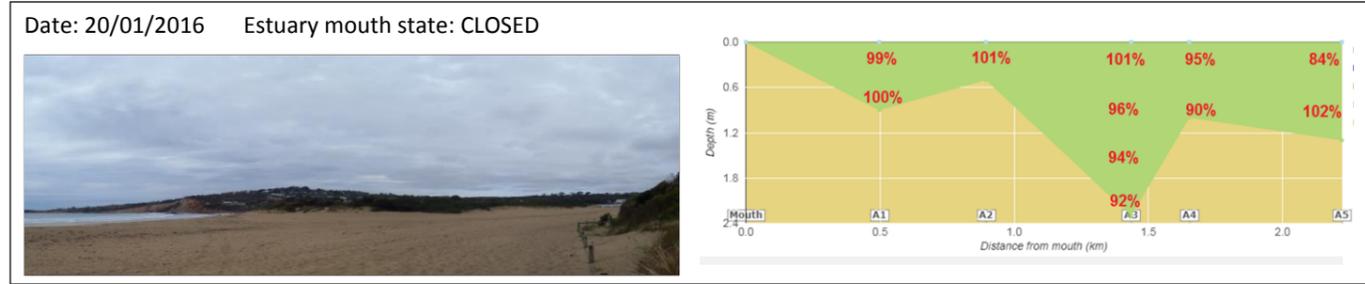
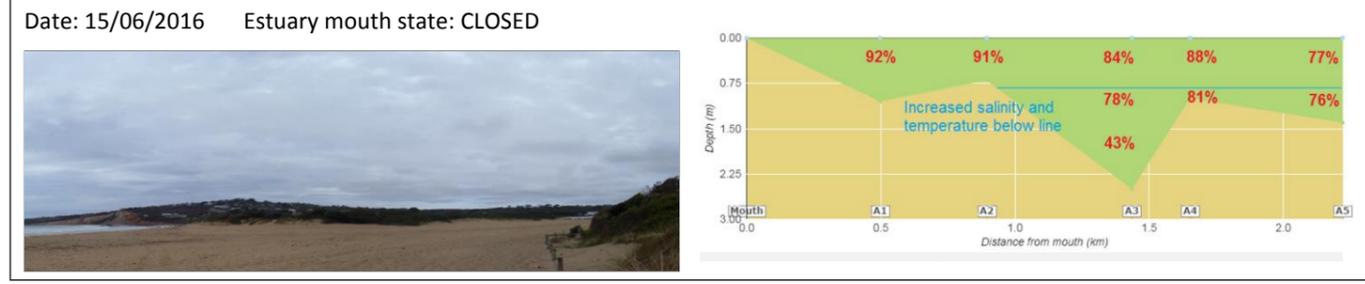
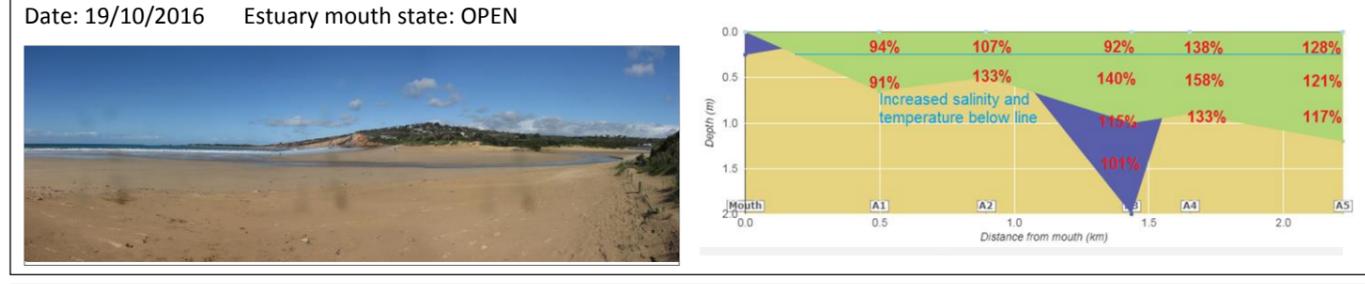
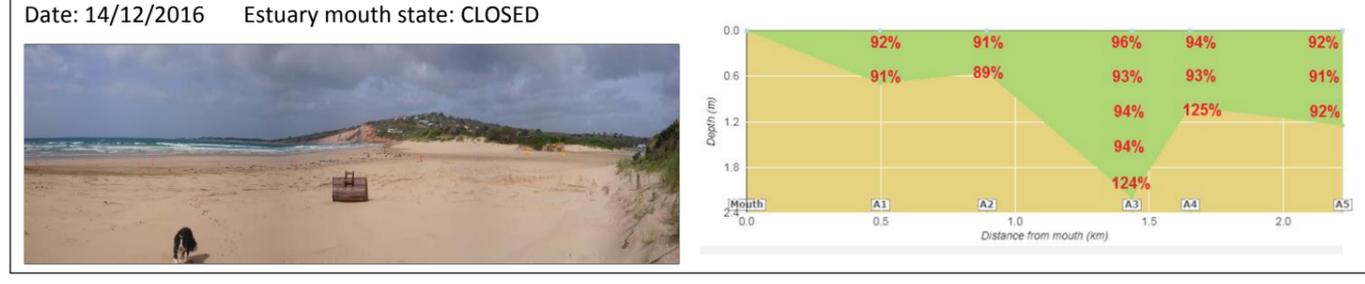
For all four monitoring sessions chosen for the Estuary Snapshots, photo point photos and a longitudinal profile of the estuary from site A1 (Anglesea Visitors Centre) to site A5 (Culvert at Coalmine Rd) is displayed. The longitudinal profile shows the depth, salinity and percent saturation of dissolved oxygen (DO) at each monitoring site from the surface of the water column to the bottom. Of additional interest is the increase in salinity and temperature below a certain depth.

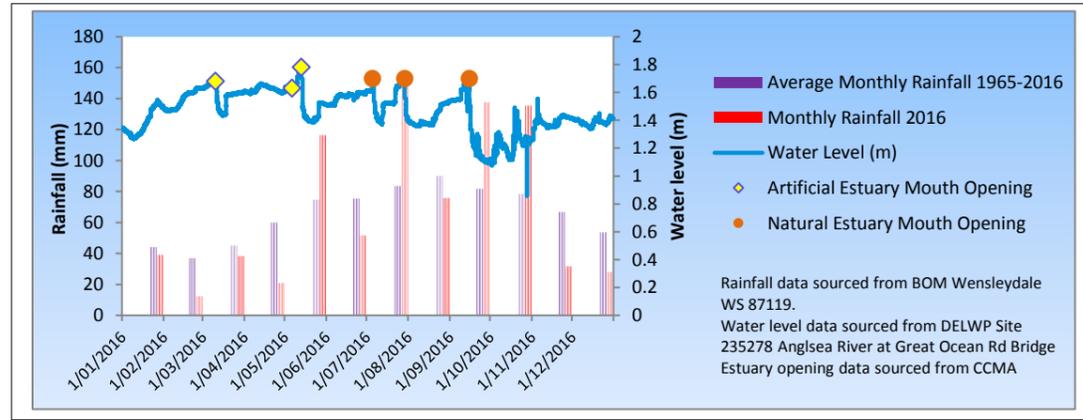
A comparison of long term average monthly rainfall with 2016 monthly total rainfall, including estuary water level. Also displayed are the estuary mouth openings both natural and artificial for the Anglesea River estuary.

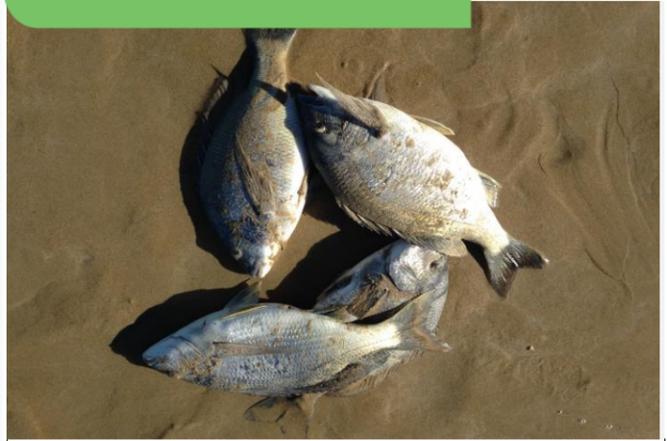
Dead bream found at the mouth of the Anglesea River on September 20.

On September 20 2016, a large number (in the 100's) of dead or dying fish were observed at the mouth of the Anglesea River estuary. A large numbers of fish were also observed leaving the mouth of the estuary and entering the sea.

EstuaryWatch monitoring one day later revealed extremely low pH levels at all monitoring sites within the estuary. pH levels ranged from 3.4 – 4.3 pH units. The acidic water, from catchment sources was washed into the river system by the above average soaking rainfall experienced prior to the event. The Anglesea River experiences occasional acidic or low pH water quality events, these events are natural occurrences and have been responsible for fish deaths in the past.
