WYE RIVER ESTUARY 2016

An interpreted summary of data

Date range:
01.01.2016 – 31.12.2016

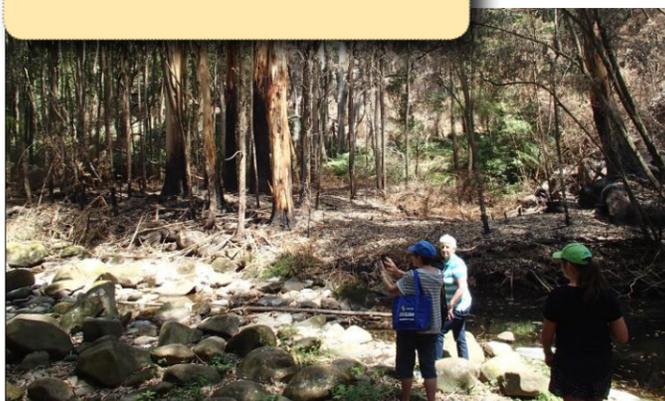
Estuarywatch volunteers inspect the dry bed of the Wye River upstream of the caravan park.

On December 25 2015, Wye River and Separation Creek were devastated by bushfire, firefighting efforts resulted in significant extraction of water from Wye River resulting in the drying of the river upstream of the township to a point that the river could not supply enough water for the town's hotel, shop and caravan parks. Water was transported into the town and stored in large tanks to keep the town watered over the busy holiday period. Impacts on river systems following bushfires have been well documented. Impacts include increased catchment erosion as the charred landscape is washed by rainfall resulting in increased inputs of sediment, nutrients and debris into the river systems. Sediment inputs can create sandy slugs that slowly move down the river system. Nutrient inputs can lead to algal blooms, and debris can block and damage structure such as bridges.

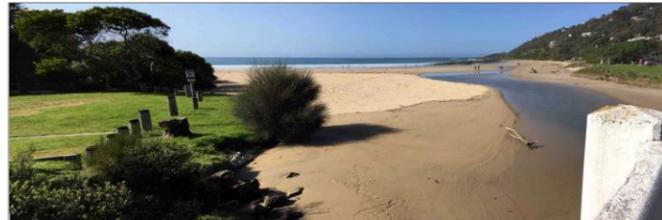
Date: 30.01.2016 Estuary mouth state: CLOSED

EstuaryWatch mouth observations on 16.01.2016
Water level: 1.45m AHD
Sea state: Smooth
Wind strength: Light breeze
Waterwatch water quality monitoring on 29.01.2016
Dissolved Oxygen per cent saturation: 80%
Turbidity: <10NTU
pH: 7.5
Salinity: < 2ppt
Water Temperature: 18°C

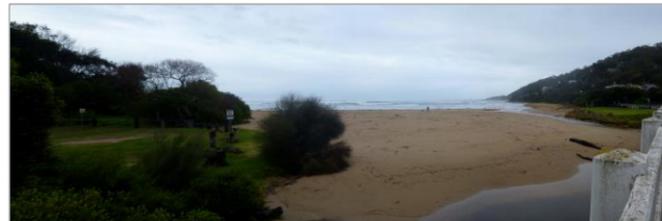
Date: 5.06.2016 Estuary mouth state: OPEN

EstuaryWatch mouth observations
Water level: 1.40m AHD
Sea state: Moderate
Wind strength: Calm
Waterwatch water quality monitoring on 4.06.2016
Dissolved Oxygen per cent saturation: 87%
Turbidity: 1 NTU
pH: N/A
Salinity: < 2ppt
Water Temperature: 14°C

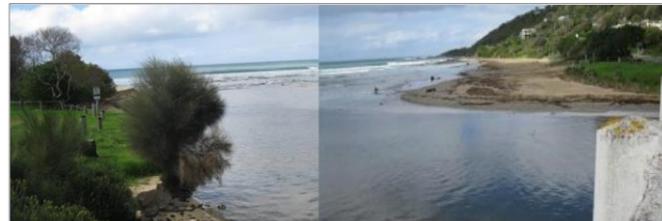
Date: 18.09.2016 Estuary mouth state: OPEN

EstuaryWatch mouth observations on 4.09.2016
Water level: 1.57m AHD
Sea state: Smooth
Wind strength: Light air
Waterwatch water quality monitoring on 4.09.2016
Dissolved Oxygen per cent saturation: 83%
Turbidity: 0.9 NTU
pH: 7.5
Salinity: < 2ppt
Water Temperature: 12°C

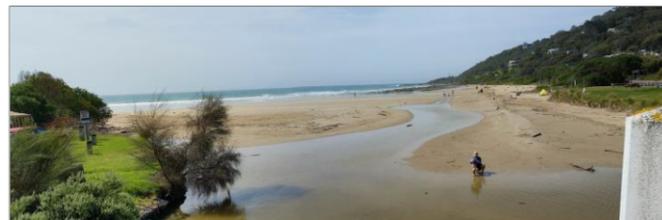
Date: 4.12.2016 Estuary mouth state: OPEN

EstuaryWatch mouth observations
Water level: 1.40m AHD
Sea state: Slight
Wind strength: Gentle breeze
Waterwatch water quality monitoring
Dissolved Oxygen per cent saturation: 92%
Turbidity: 1.0 NTU
pH: 7.2
Salinity: < 2ppt
Water Temperature: 18°C

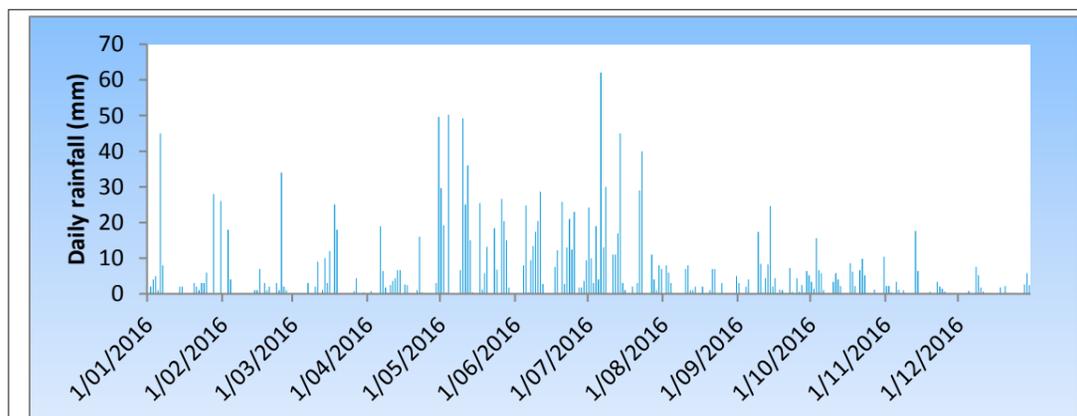
Daily rainfall for 2016 recorded at Mt Sabine rain gauge (Site 90183). The highest total daily rainfall was recorded on July 6 2016 (62mm). Data sourced from DELWP.

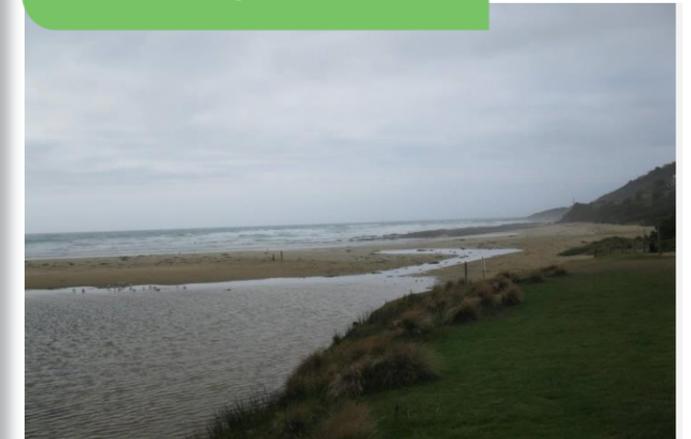
The Wye River estuary mouth finally opens on January 21 2016 after 72mm of rainfall fell in the catchment over the previous three weeks.
